Capacitive Imaging Technique for the Inspection of Composite Sucker Rod

Kefan Wang, Xiaokang Yin^{*} , Chen Li, Wei Li and Guoming Chen

Abstract

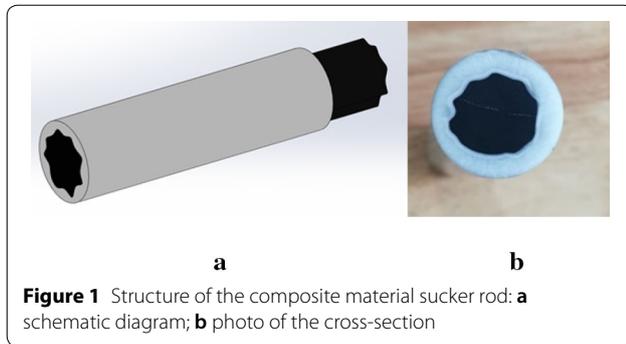
The composite sucker rod studied in this work is a carbon fiber pultruded multi-layer structure, which is shown in Figure 1. It's a hybrid fiber-reinforced polymers (FRPs) structure possesses both advantages of carbon fiber reinforced polymer (CFRP) and glass fiber reinforced polymer (GFRP) [1–4]. The carbon fiber core is a reinforcement in the center with its surface covered by a layer of glass fiber mixed with resin. The carbon core has an irregular profile to increase friction between layers to further increase the overall strength. Due to the complicated production process, there might be geometric imperfections (i.e., eccentricity of the carbon core). In addition, during its service life in the harsh environment, many type of defects, such as wearing, cracks and ageing, could happen to the sucker rod. The above mentioned manufacturing and in service defects will greatly affect the performance of the

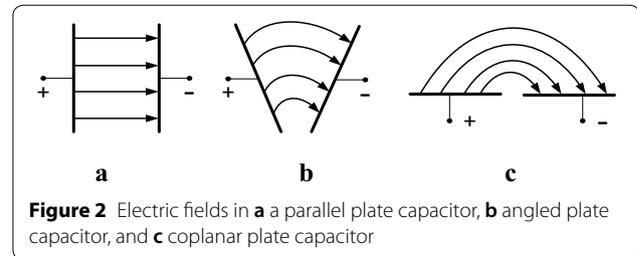
The general principle of CI technique is shown in Figure 2. A capacitive probe is changed from being a parallel plate capacitor to a coplanar structure. When the capacitor is a parallel plate capacitor, with a DC energization a uniform electric field will be established between the parallel electrodes, as shown in Figure 2(a). If the parallel electrodes are opened at an angle as shown in Figure 2(b), the uniform electric field changes into a fringing field. Finally, if the parallel electrodes are further opened to be coplanar, the fringing electric field will become the main effect as shown in Figure 2(c). Exciting the driving electrode with a DC voltage will produce a fringing electric field which can induce charges on the sensing electrode and the amount will vary depending on the properties of material under test. The capacitive probe can then get the defects information by measuring the charges from the sensing electrode.

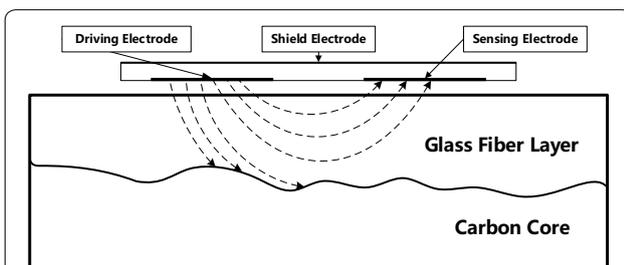
Figure 3 General principle of the CI technique used in the inspection of composite sucker rod

When used on the composite sucker rod, the probing electric field will penetrate through the air gap between the capacitive probe and the glass fiber layer of the rod, and form a certain field distribution in the glass fiber layer. Any anomaly within this layer will change the field distribution and ultimately change the capacitance. The electric field will then terminate on the conducting carbon core and form an equal-potential surface. The distance between the probe surface and carbon core surface (defined as lift-off) will also

change the capacitance. Therefore, the CI technique is considered useful to detect the defects in the glass fiber layer and characterize the surface of the carbon core, as shown in Figure 3.

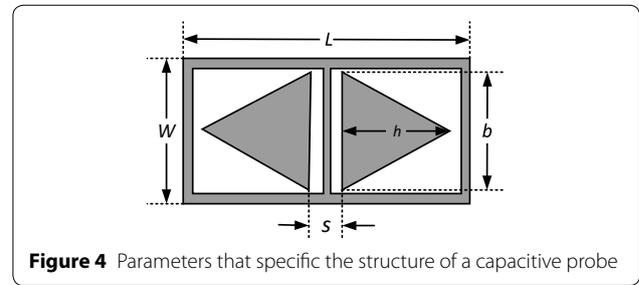
Figure 4 Parameters that specific the structure of a capacitive probe

where the \vec{E}_D and \vec{E}_S are the electric fields in the location of regions when the driving electrode and sensing electrode were stimulated by a unit voltage respectively. Such electric fields from reciprocal energization can be easily obtained in Finite Element models as described in detail in previous work [21]. Coplanar capacitive probe with two triangular electrodes is selected in this case, as the triangular electrode can balance the trade-offs in the probe design. The triangular probe can be specified by the overall width (W), the overall length (L), the base (b) and height (h) of each triangle and the separation distance (s) between the parallel edges of the two triangles as shown in Figure 4.

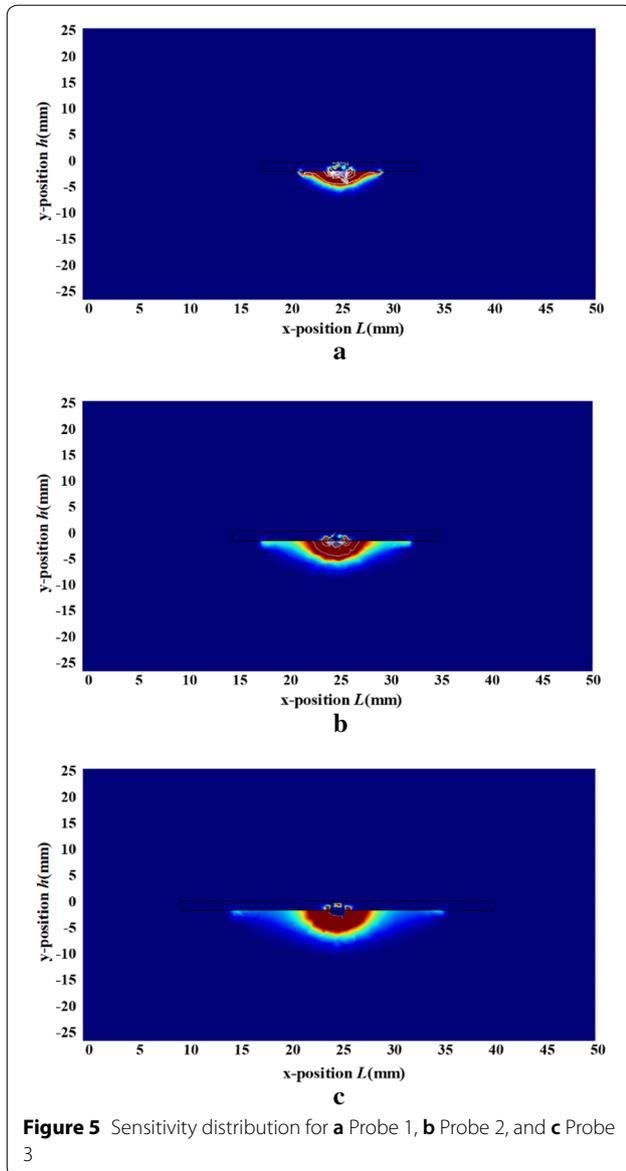
Three probes with specifications indicated in Table 1, were studied to identify suitable parameter combinations. The sensitivity distributions for the CI probes are show in Figure 5. Note that the sensitivity distribution a 3D, for a clearer illustration, only one cross-section

along the long axis of symmetry of the CI probe is plotted. The color maps were set in the same range, so direct comparison can be made more accurately. As shown in Figure 5, the high sensitivity area (referred to as volume of interrogation) is bigger with the sensor size increases.

Bigger volume of interrogation means bigger inspection extent in a single measurement position, so from the sensitivity distribution map one can briefly infer the penetration depth and signal strength of a given CI probe. It can be seen from Figure 5 that Probe 1 can get about 4 mm penetration depth, Probe 2 is with an approximate 6 mm penetration depth and Probe 3 is with a 9 mm penetration depth. Generally, a bigger penetration depth is favorable in the CI measurement, but this is trade-off against imaging resolution. The diameter of the composite sucker rod studied in this work is 22 mm, and the thickness of the outer glass fiber layer is between 2 mm to 5 mm. A suitable CI probe should have a big enough penetration depth to cover the whole range of insulation layer and to have a relatively small volume of interrogation to have a reasonable imaging resolution. Therefore, Probe 2 (with a 6 mm penetration depth) was chosen for the later simulations and experiments.

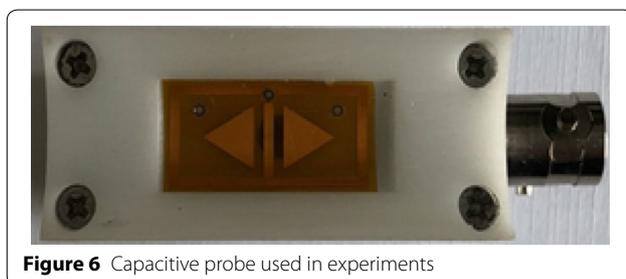
For better measurement results, a slight modification was done to the coplanar CI probe. A flexible PCB was used to replace the conventional rigid FR4 PCB and a curved substrate was manufactured using 3D printing to fit the surface of the sucker rod specimen, as shown in Figure 6.

The specifications of the capacitive probe are the same with the ones used in the experiments (shown in Figure 6). The simulated sucker rod comprises three layer including carbon fiber core (12 mm in diameter), glass fiber outer layer (4 mm thick) and a thin (1 mm) resin layer in between. The computational domain is $400\pi \times 90 \text{ mm}^3$ with 72535 elements after meshing. The diameter of the simulated sucker rod is 22 mm which is the same as the rods tested in the experiments as will be presented in Section 4. The material properties of three layers are set as follows: carbon fiber (fiber direction: axial, grounded conductor), glass fiber (fiber direction: circumferential direction, $\epsilon = 4.7$), and epoxy resin ($\epsilon = 3.5$). The driving electrode is energized by 1 V DC voltage and the sensing electrode is set to be “floating”. The back plane of the CI probe is set to be grounded as a shielding. Other boundaries in the model are set to be “continuity”. The capacitances are calculated between the driving and sensing electrode.

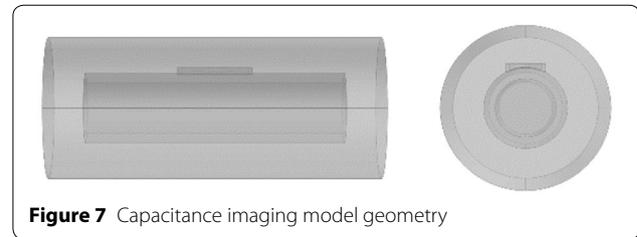
of the CI technique. The 3D model geometry is shown in Figure 7. The outer cylinder is the computational domain which is filled with air ($\epsilon = 1$) in the simulation.

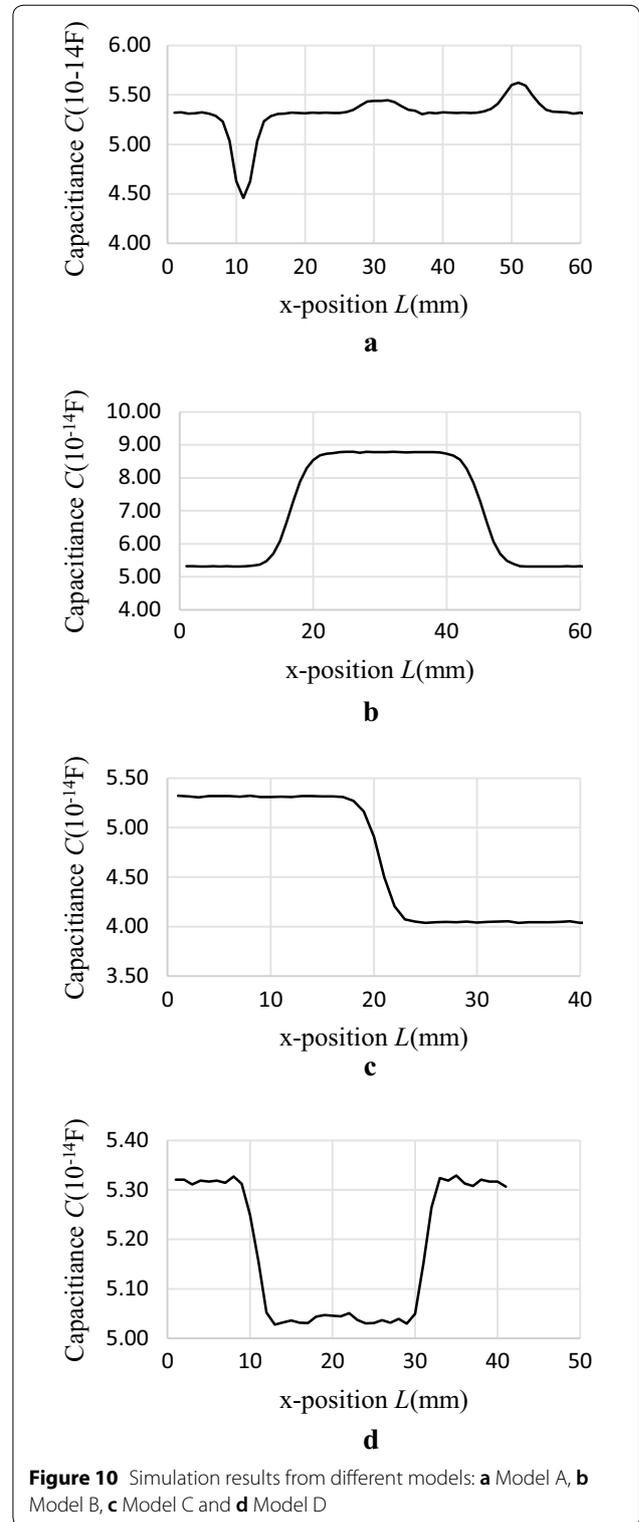
Simulated scans were performed with a CI probe scanned along the axial direction in the four models and the results are shown in Figure 10. All the three defects in Model A produced clear indications in the line scan

results, as shown in Figure 10(a). The three defects at different buried depth produced different capacitance variation trends, one defect appeared as a depression and

the other two appeared as bulges. In this simulated scan, same type of defects produced different indications. This is due to the distribution of negative measurement sensitivity values. If a defect is situated in a negative measurement sensitivity value zone, it will bring in opposite contributions to the measured capacitance [31]. The layered defect in Model B were detected as a clear bulge, as shown in Figure 10(b). The carbon core with stepped diameter in Model C is clearly shown as a step shaped curve, as shown in Figure 10(c). The surface crack in Model D is also successfully detected as a depression in the obtained capacitance plot, as shown in Figure 10(d). The results from the four models further demonstrated the feasibility of the CI technique to detect various types of defect in the composite sucker rod.

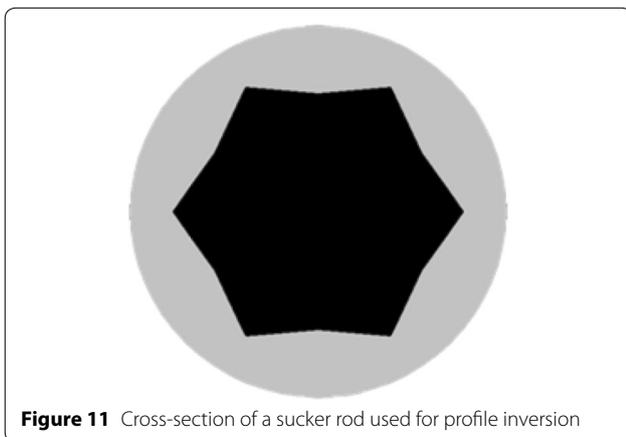
Figure 11 Cross-section of a sucker rod used for profile inversion

The carbon core of the composite sucker rod usually has an irregular profile of its cross-section to enhance the strength. The fluctuant surface is not regarded as local defect in general. However, the complex pultrusion manufacturing process might bring in geometric defects, such as the eccentricity of the carbon core and shrunk/expanded carbon core cross-section area. Such geometric defects will significantly reduce the strength of the entire sucker rod. It is thus important to obtain the profile, as a quality control measure. As discussed in Section 2.1, CI probe is sensitive to uneven surface of the carbon core. If scanned around the circumference of the sucker rod, the CI output will reflect the profile of the carbon core. However, to obtain the actual profile of the core, post processing of the obtained data is required. An inversion method is proposed and implemented in an FE model. A composite sucker rod with a pentagon-like shaped carbon core was constructed in the FE model, and the carbon core cross-section is shown in Figure 11.

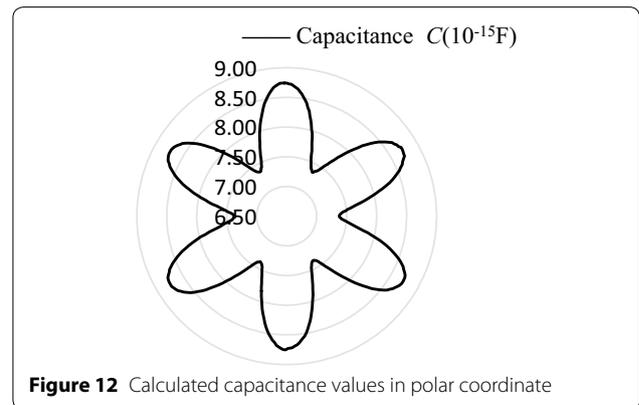
Figure 12 Calculated capacitance values in polar coordinate

A simulated CI line scan along the circumference of the sucker rod was performed using the curved CI probe at a minimal lift-off. The calculated capacitance values at each scan point is plotted in the polar coordinate, as shown in Figure 12. It is obvious that Figure 12 is not the outer profile of the carbon core as the radius in the polar plot is measured (calculated) capacitance value, rather than the actual radius of the carbon core.

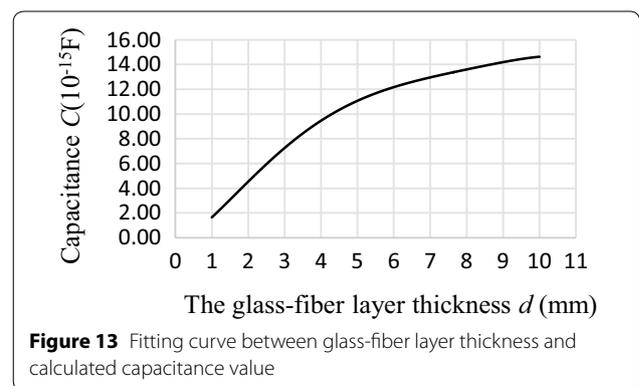
Figure 13 Fitting curve between glass-fiber layer thickness and calculated capacitance value

A relationship between measured (calculated) capacitance value and the radius of the core is thus required to map the polar plot of capacitance values to the profile of the carbon core. To find this relationship, a parametric FE model is built. In this model, the capacitance values of the CI probe with increased lift-offs (equivalent to the thicknesses of the glass fiber layer) at a 0.2 mm interval are obtained. A fitting curve of the calculated capacitance values (C) against lift-offs (d) is shown in Figure 13 and the fitting formula is:

$$C = x_1 d^5 + x_2 d^4 + x_3 d^3 + x_4 d^2 + x_5 d + x_6, \quad (2)$$

where $x_1 = -7.468^{-19}$, $x_2 = 2.226^{-17}$, $x_3 = -2.316^{-16}$, $x_4 = 8.141^{-16}d$, $x_5 = 1.762^{-15}d$, $x_6 = -7.226^{-15}$.

A clear non-linearity can be observed in Figure 13.

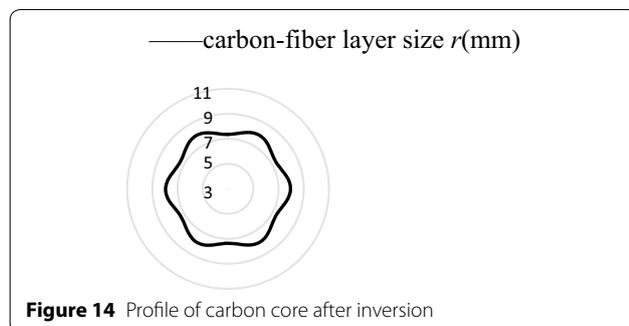
Figure 14 Profile of carbon core after inversion

The fitting formula is then used to calculate the actual lift-offs d (the thickness of the glass fiber layer), and the real radius of the carbon core at each scanning step can finally be obtained by subtracting the d value from the radius of the sucker rod (11 mm in this case). The final inversion result is shown Figure 14. Comparing Figure 14 and Figure 11, the profile of the carbon core is roughly reflected from the CI data after the proposed inversion method. It should be noted that, the obtained plot is not as sharp as the actual profile, because the CI probe works in a volume averaging manner thus has a blurring effect. The blurring effect is more significant in the cases when the probe size is bigger compared to the targeted feature.

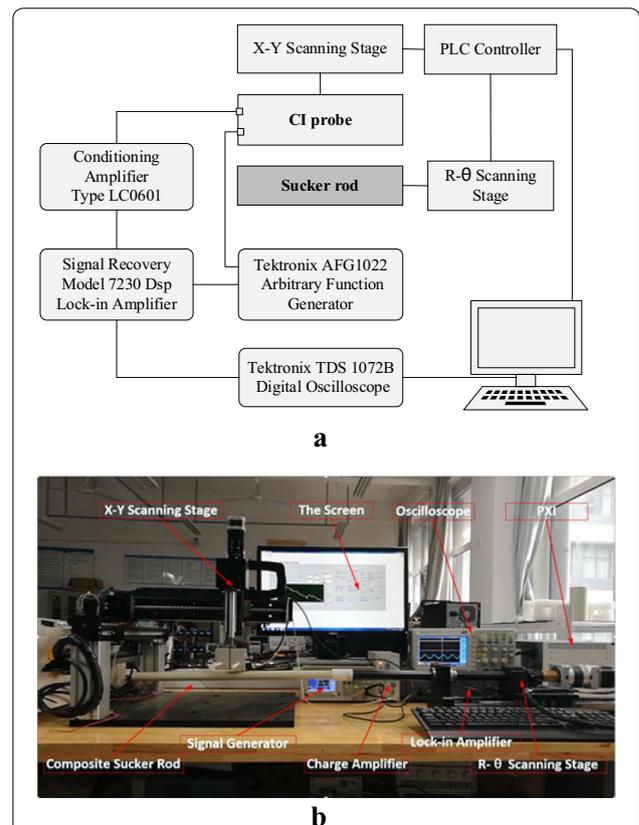
Figure 15 Capacitance imaging instrument: a block diagram, and b photo of the instrument

The CI signal generating and processing system includes a signal generator (Tektronix AFG1022 Arbitrary Function Generator), a charge amplifier (Conditioning Amplifier type LC0601), a lock-in amplifier (Signal Recovery Model 7230 DSP Lock-in amplifier), an oscilloscope (Tektronix TDS 1072B Digital Oscilloscope), and an NI PXI system. The motion control system includes an X - Y - Z three-axis scanning stage and an R - θ rotary stage for the motion control in the scanning experiments. The schematic diagram and the photo of the CI instrument are shown in Figure 15.

With the above mentioned instrument, an AC capacitance measurement method is used to achieve a better signal to noise ratio. The driving electrode of the CI probe is excited by the signal generator with an AC voltage (10 V pk-pk @ 10 kHz). At 10 kHz, the quasi-static approximation is appropriate and the probing field can be regarded as a static electric field. Therefore, the statements and analysis made in Section 2.1 are valid. The charge signal induced on the sensing electrode is taken by the charge amplifier and converted to a voltage. The voltage signal is then fed into the dual channel lock in amplifier, and the DC output from the lock-in amplifier is recorded by the NI PXI system. The motion control

system can manipulate the CI probe to perform an actual scan. Software developed in LabVIEW is installed in the NI PXI system for data acquisition and motion control.

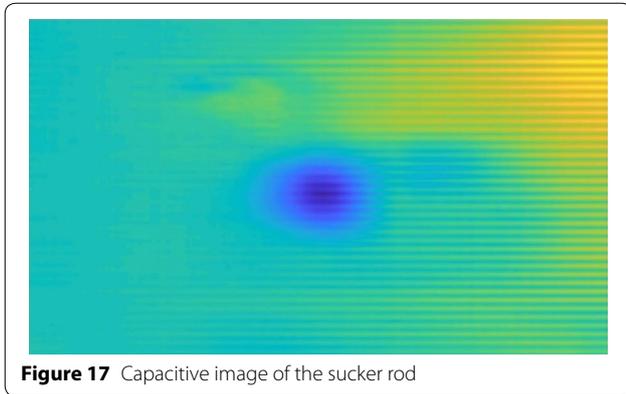
Figure 17 Capacitive image of the sucker rod

CI experiment was performed on a composite sucker rod specimen with a surface wearing defect. The wearing defect was made in the lab and is very shallow (less than 0.1 mm), as shown in Figure 16. In practice, such slight wearing defect may not be easily seen as its color may be very close to its surrounding area. A 60 mm by 10 mm CI scan was performed in the boxed area indicated in Figure 16 and the capacitive image is shown in Figure 17. It can be seen from Figure 17 that, the wearing defect is clearly seen in the capacitive image. Note that there are

intensity variations in the background (defect free) area due to the uneven surface of the carbon core.

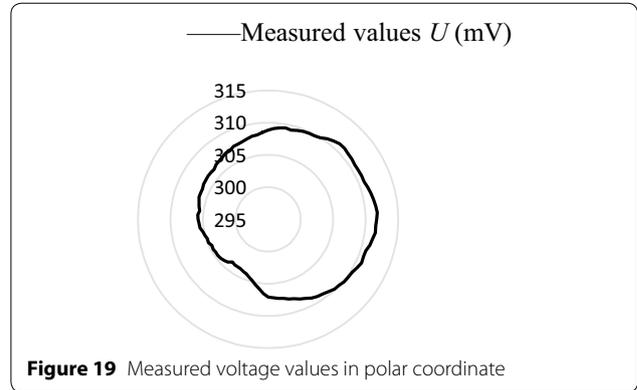
Figure 19 Measured voltage values in polar coordinate

The CI probe was scanned around the circumference of the sucker rod. Firstly, as in Section 3.4, the measured value is directly plotted in the polar coordinate, as shown in Figure 19.

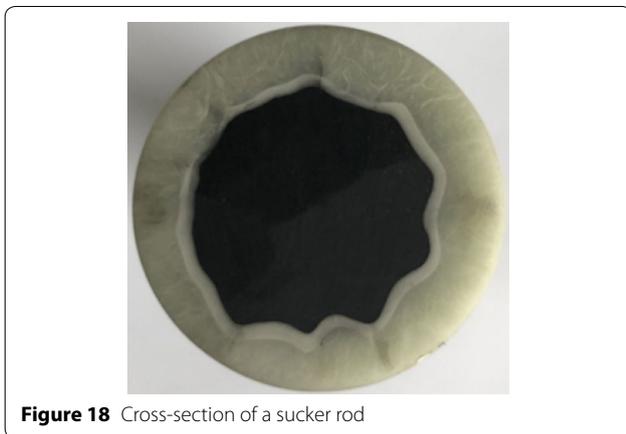
Figure 18 Cross-section of a sucker rod

A CI scan was done in an attempt to obtain the carbon core profile and verify the inversion method proposed in Section 3.4. The cross-section of the sucker rod is shown in Figure 18.

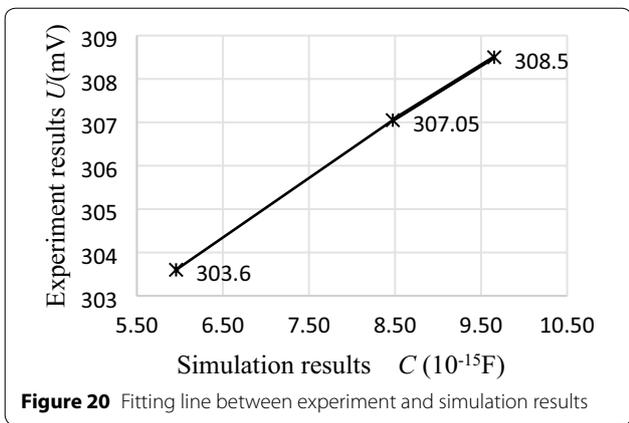
Figure 20 Fitting line between experiment and simulation results

fitting formula obtained in Section 3.4. The CI instrument is a linear measurement system with fixed overall gain and DC drift. Therefore, the relationship between the calculated capacitance in FE model and measured voltage output in experiment should be linear. Three CI readings taken at know lift-offs are used to find the linear relation between calculated capacitance in FE model and measured voltage output in experiment, the selected points are shown in Table 2. The three measurement points are with 2.5 mm, 3.5 mm and 4.1 mm glass fiber layer thickness. CI readings at these selected points were taken. Combining with the simulated results in Section 3.4, a relation between the measured voltages (U) and capacitance values (C) from simulation can be established. The fitted line is shown in Figure 20 and the corresponding fitting formula is:

$$U = 1.332^{15}C + 295.7, \tag{3}$$

where U is the voltage value recorded in experiments and C is the calculated capacitance in the FE model.

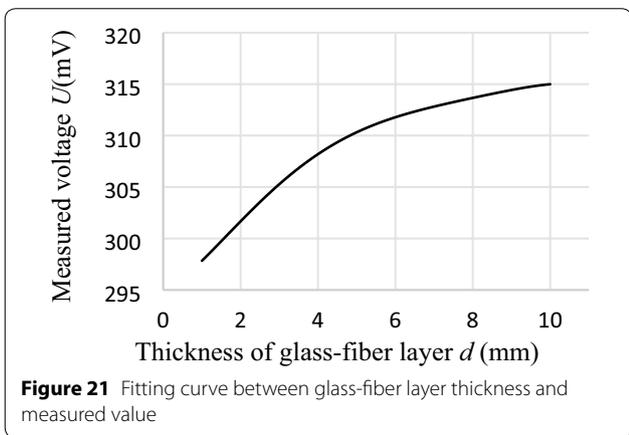
Figure 21 Fitting curve between glass-fiber layer thickness and measured value

Finally, combing Eq. (2) and Eq. (3), a curve of the measured voltage (U) against lift-offs (d) can be obtained and is shown in Figure 21. The corresponding fitting formula is:

$$U_c = x_1d^5 + x_2d^4 + x_3d^3 + x_4d^2 + x_5d + x_6, \tag{4}$$

where $x_1 = -9.89^{-4}$, $x_2 = 2.949^{-2}$, $x_3 = -0.3069$, $x_4 = 1.079$, $x_5 = 2.334$, and $x_6 = 294.7$.

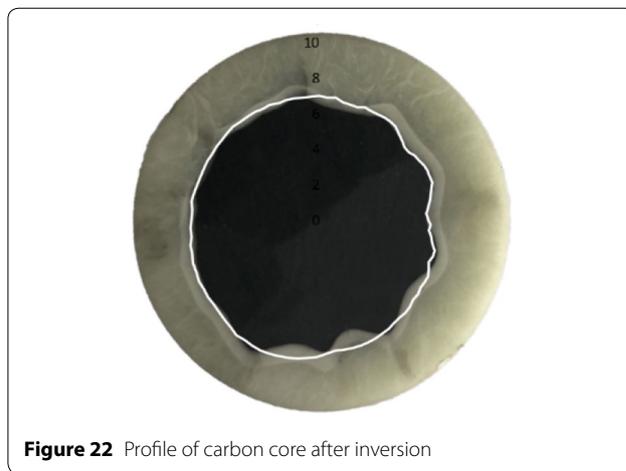
Figure 22 Profile of carbon core after inversion

The fitting formula (Eq. (4)) can then be used to calculate the actual lift-offs d (the thickness of the glass fiber layer), and real radius of the carbon core at each scanning step can finally be obtained by subtracting the d value from the radius of the sucker rod (11 mm in this case). The final inversion result is shown as white line in Figure 22. The actual cross-section of the sucker rod in also included for direct comparison. Although the obtained plot is not as sharp as the actual profile, the profile of the carbon core can be roughly reflected from the CI data after the proposed inversion method. The rapid change of the carbon core profile (e.g., the bottom-right part) is “ignored” by the CI probe, because the CI probe is less sensitive to features much smaller compared to its size.
